PUMPABLE ROOF SUPPORTS: DEVELOPING DESIGN CRITERIA BY MEASUREMENT OF THE GROUND REACTION CURVE

Thomas M. Barczak, *Geophysicist*
National Institute for Occupational Safety and Health
Pittsburgh Research Laboratory
Pittsburgh, Pennsylvania USA

ABSTRACT

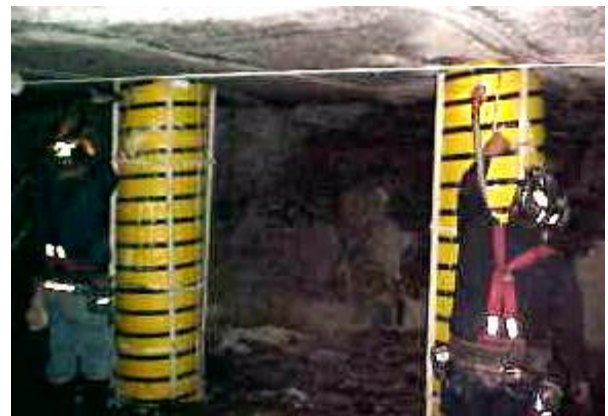
Figure 1. Pumpable roof support being installed in a longwall tailgate.

several alternative support technologies have been developed, including pumpable roof support systems. As the name implies, a pumpable roof support is one in which the support is formed in place in the mine entry by pumping material, such as a cementitious grout, into some form of a containment structure, typically a bag that is hung from the mine roof (figure 1). One major advantage of the pumpable roof support system is that it reduces the material handling difficulties that are common with most other forms of standing roof support, thereby expediting the installation process as well as reducing material handling injuries which are prevalent with many other support systems (1-2).

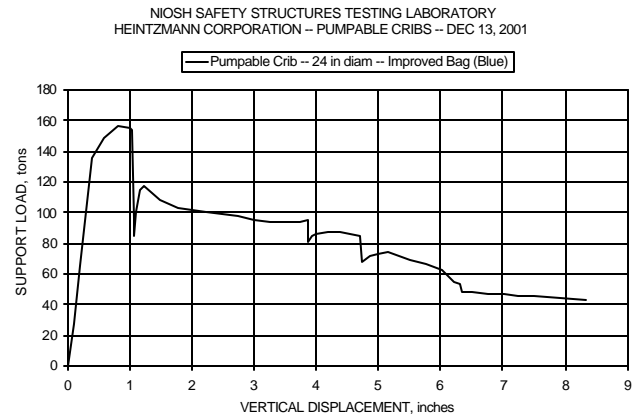
Figure 2. Loading profile of 24-inch diameter (Heitech) pumpable roof support.

Figure 2 illustrates the loading characteristics of the Heitech pumpable roof support from full-scale testing conducted in the National Institute for Occupational Safety and Health's (NIOSH) Mine Roof Simulator. The support loading profile is characterized by a high initial stiffness with peak loading occurring at less than one inch of displacement, followed by significant load shedding with a post failure capacity comparable to that of wood cribbing. Hence the key to optimizing the support utilization is to prevent convergence beyond the peak loading capacity from occurring in areas where critical roof support is needed. Control of the roof depends on a certain level of support capacity. The question then becomes "what needs to be done to ensure that the peak loading does not occur?" If the loading environment is bad-controlled within the realm of the available support capacities, meaning the equilibrium of the roof and floor is related to the support resistance, then this can be accomplished by installing the proper number of supports to provide a support load density that will establish equilibrium of the rock mass before the convergence reaches a level where peak support capacity will occur (3). However, all longwall mining operations have some degree of displacement-controlled loading, meaning that some convergence will occur regardless of the support system in use. For example, pillar yielding cannot be prevented by any man-made standing support. Hence, pillar yielding produces roof-to-floor convergence of the tailgate, which induces displacement on the pumpable support, regardless of its size, design, or the number and arrangement of supports installed in the longwall tailgate (4). Floor heave and compressional (buckling) failures of the bolted roof beam due to horizontal stress may also have elements of displacement-controlled loading. A critical question then becomes, "how much displacement-controlled loading is occurring in a particular longwall tailgate?" If it is more than 1 inch, then the pumpable roof supports will be pushed beyond their peak capacity, leaving only their residual capacity to support the mine roof, and this may not be adequate in all circumstances.

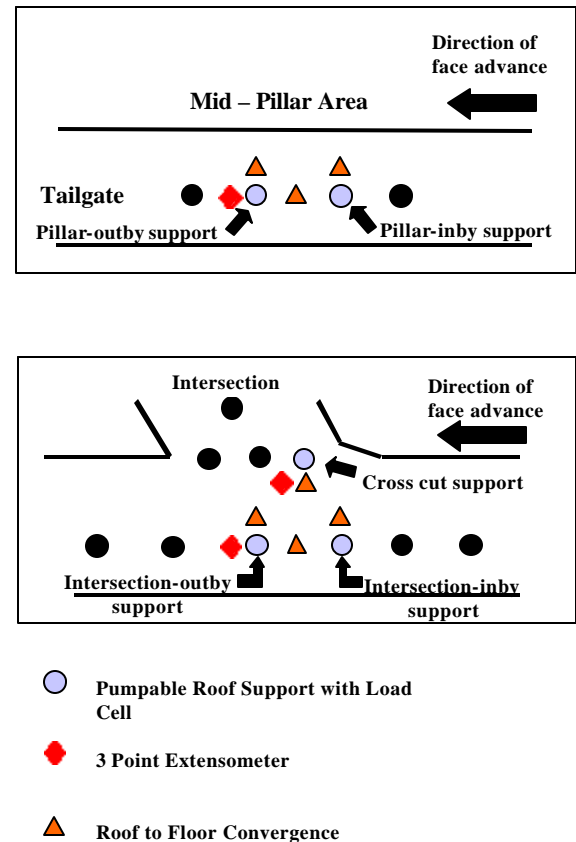
Figure 4. Instrumentation arrangement for each pumpable roof support area of study.

The instrumentation arrangement for each of the three study areas is shown in figure 4. Instrumentation was at the mid-pillar and intersections. A permissible Campbell Scientific multiplexor and data logger was used at each of the three test sites to provide continuous recording of the instrumentation. The cables for the sensors were run outby to allow monitoring of the instrumentation inby the face on Sites B and C while site A was monitored until the face area reached the intersection. The cables were laid against the coal pillar and covered with the grout used to fill the pumpable supports. This grout layer would protect them from damage due to rock falls and pillar sloughage. In the intersections, the cables were covered with a foaming agent, typically used to seal around the perimeter of ventilation seals and stoppings, to provide protection to the cables in these areas.

Load was measured on five supports at each of the three study sites: (1) two adjacent supports at the mid-pillar area, (2) two adjacent supports in the entry at the intersection, and (3) one support in the crosscut corner at the intersection. Loading was measured by a 26-in-diameter hydraulic flatjack cell. The flatjacks were filled with water and calibrated to a pressure of 600 psi in the NIOSH Mine Roof Simulator. The flatjack was placed on top of the support prior to being fully filled with grout, and then it was pushed tightly against the mine roof as the support was completely filled. The flatjack was instrumented with a 1,000 psi pressure transducer and gage to record the pressure as the support load developed.

Roof-to-floor convergence was measured at each of the supports that were instrumented to measure support loading. The convergence was measured approximately 1 ft from the pumpable roof support. Twelve-inch-long rebar bolts were grouted into the mine roof and floor to provide anchors which would eliminate movements of the skin of the mine roof and floor in the convergence measurements. A displacement transducer was

mounted to the plate on the roof anchor and connected to a floor anchor by a wire to measure the roof-to-floor convergence. Roof-to-floor convergence was also measured between the two, flat-jack-instrumented supports located at the pillar area and intersection to help evaluate the zone of influence of the pumpable support.

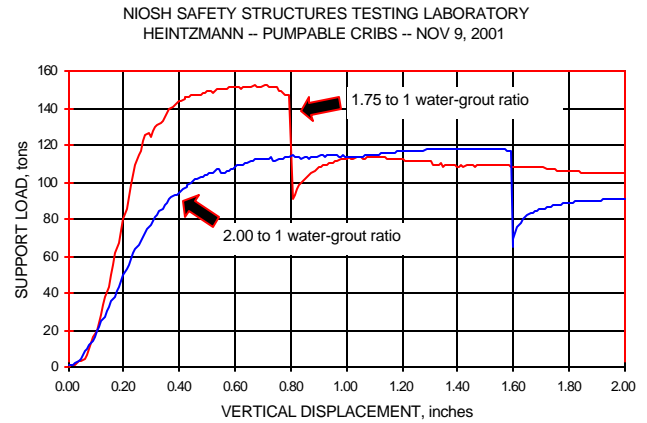
Figure 5. Loading profile of 1.75 to 1 and 2.00 to 1 water-solids ratio showing reduced stiffness and peak capacity of support with the higher water content.

It is expected that the grout with the higher water content would not only lower the compressive strength of the grout, but also reduce its modulus of elasticity, thereby reducing the initial stiffness of the full-scale support. Figure 5 illustrates the load-displacement response of full-scale supports tested in the NIOSH Mine Roof Simulator. It can be seen from this graph that the initial stiffness of the support with higher water content was lower. The lower support stiffness indicates that the support with a 2.00 to 1 water-solids ratio would require more roof-to-floor convergence to provide the same load as the support with a 1.75 to 1 water-solids ratio. The supports with the higher water content also produced lower peak loads in this full-scale test, which is expected since the grout strength was lower. However, the water content does not influence the post failure characteristics of the support, since the bag confinement controls the post failure response.

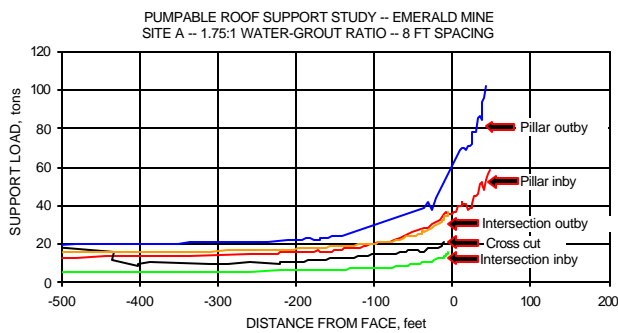
Figure 6a. Support loading for Site A.

An assessment of the underground study is broken down into the following areas: (1) tailgate performance outby the face, and (2) tailgate performance inby the face. Table 2 provides an overall summary of the support loading and figures 6a, 6b, and 6c show the support loading as a function of the face position for each support in Sites A, B, and C respectively. Table 3 summarizes convergence measurements taken at the longwall face. The study applies only to the active tailgate loading, with inby and outby referenced to the face position (inby referring to the mined out or gob area and outby referring to the un-mined section of the panel). In all figures referring to face position, inby is denoted as a positive tailgate location and outby is denoted as a negative tailgate location with the face being represented as 0. The supports were not instrumented in time to collect data during the first panel mining prior to the entry becoming an active tailgate for the study panel.

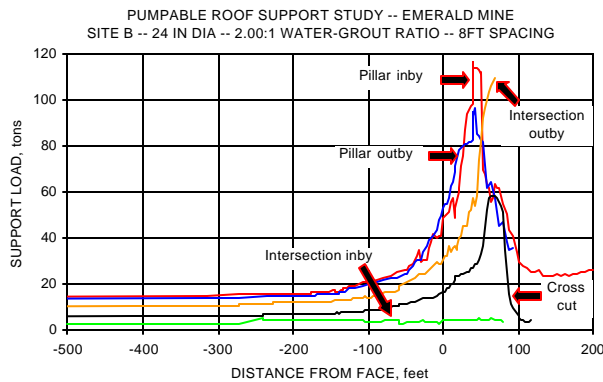
Figure 6b. Support loading for Site B.

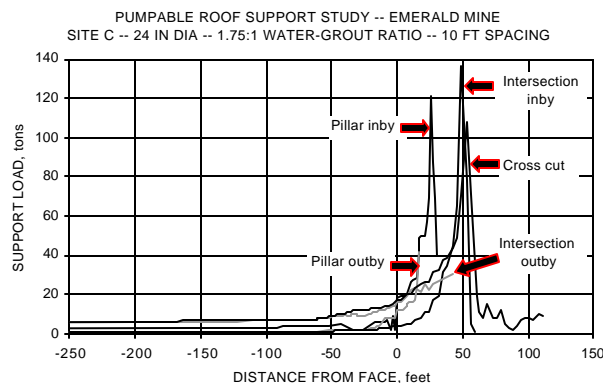
Figure 6c. Support loading for Site C.

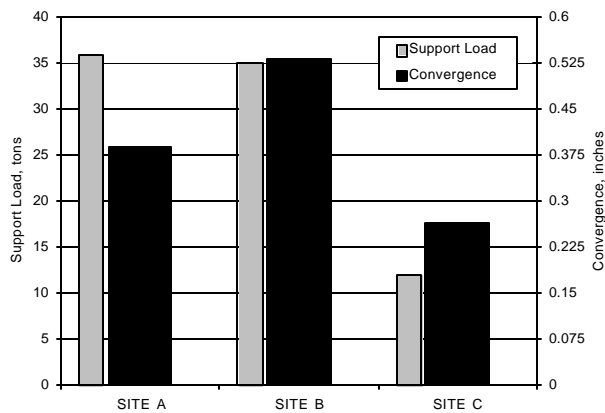
Figure 7. Average support load and convergence recorded at the three instrumentation sites.

Overall, the support loading outby the longwall face was minimal, and the tailgate conditions were excellent. The chart in figure 7 shows the average support load and convergence for each of the three test sites as the longwall face passed the instrumented supports. Site A and B had similar load developments, approximately 35 tons on average, but the convergence in Site B was on average higher than Site A. This is consistent with the pumpable crib material properties for Site B has the higher water content, which as previously shown, reduces the material modulus and initial stiffness of the support. As shown in figure 7, Site C exhibited considerably less loading and convergence outby the face than the other two sites. It is also seen that Site C felt the effects of the front abutment later (closer to the face) than did site A or B (figure 8). The response observed in Site C suggests that there was some difference in the ground conditions at Site C compared to A and B. It would be expected that Site C with the widest spacing (10 ft compared to 8 ft for Sites A and B) and consequently the lowest support density, would have the highest loading and convergence. The precise differences in conditions remain unknown. Factors that could result in less convergence would include (1) less pillar yielding, and (2) more competent roof and/or floor. Unfortunately, the uncertainty of conditions makes a direct comparison of the outby performance of Site C with Sites A and B more tenuous.

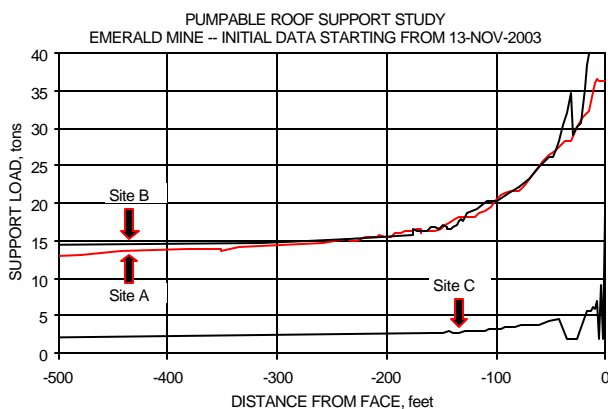
Figure 8. Site C felt the effects of the front abutment later (closer to the face) than did Sites A and B.

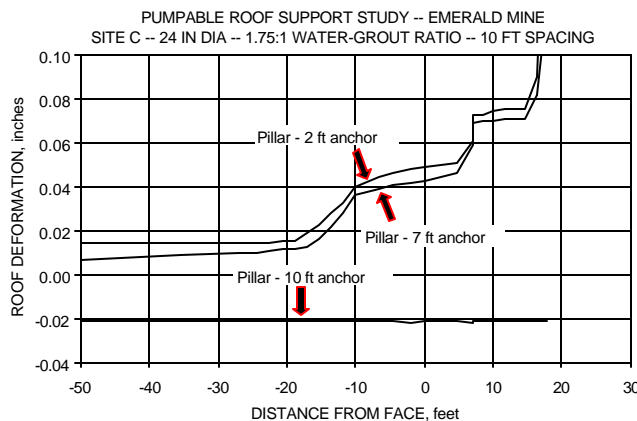
Figure 9. Example of the largest roof deformations outby the face. Overall, there were very little separations within the immediate roof.

Analysis of the roof deformation data showed that there were essentially no significant separations of strata within the first 10 feet of the roof outby the face in the instrumented areas. Some movement was detected at the 2 and 7 ft horizon as the face approached to within 25 feet of the instrumented supports in a few areas indicating some local roof loading was beginning to occur. The magnitude of the deformation at the face was still less than 0.05 inches, which is not considered to be significant in terms of roof stability or pumpable support loading. Figure 9 shows the data from the mid-pillar area roof extensometer in Site

C as an example of the most severe roof deformation outby the face.

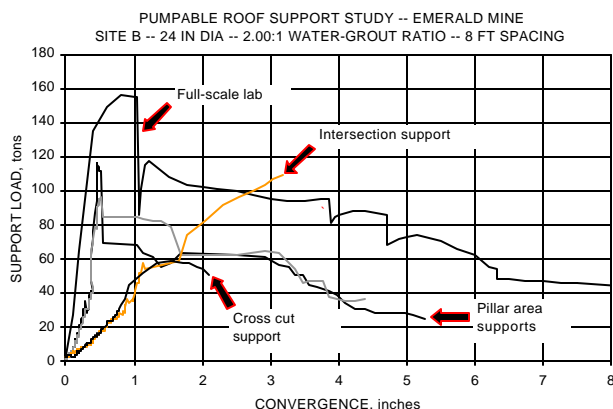
Figure 10. Load-convergence plots of supports in Site B compared to full-scale laboratory test.

A related question is, "at what load were the supports failing (exceeding their peak load capacity)?" In order to determine if the supports were failing or simply unloading prior to reaching their peak capacity, the support response must be plotted as a function of convergence. Figure 10 shows data from Site B. The pillar area supports exhibited a response similar to the full-scale lab tests, suggesting that these supports were failing although at lower loads. The following discussion is intended to evaluate this conclusion. The data presented in figure 10 represents active tailgate loading only, however, there was only about 8 tons of load remaining on the supports from the first panel mining, so this is not sufficient to account for the difference between the tailgate measurements and full-scale laboratory tests. Since the support loading data were collected every 30 minutes, it is possible that the true peak loads were not captured. However, the post failure loading which occurs over several hours is also proportionally lower than that observed in laboratory testing, suggesting the measured peak loading is fairly accurate. Hence, it appears that the conditions in the mine, most likely the roof or floor contact conditions and the resulting loading conditions were responsible for the lower capacity observed in the mine. It is likely that roof is producing eccentric loading of the pumpable support inby the face due to differential closure of the tailgate between the pillar side and caved gob material on the other side. Therefore, rather than a uniform stress as would be applied to the support by a "flat and parallel" roof and floor as would occur in

the laboratory, the pressure acting on the supports in the mine is most likely non-uniform with higher pressures acting on one side of the support than the other. However, while this may explain the lower peak load observed, it would be expected that the residual loading would not be as significantly affected by the non-uniform loading since once the material fractures, the residual loading is controlled by the bag confinement.

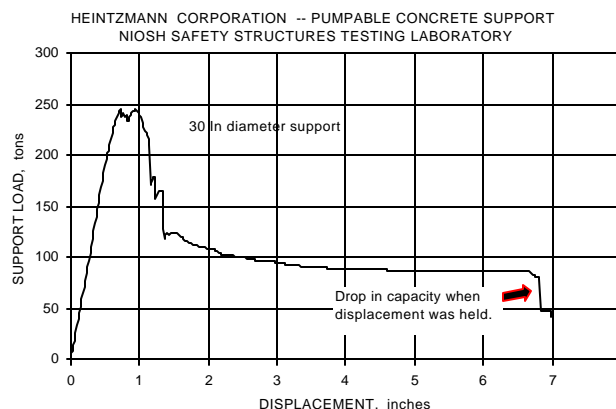
Figure 11. Load drops when displacement is held in this full-scale laboratory test.

This brings up another question, “what about the supports that exhibited essentially no residual loading?” Of the six supports in which peak loading was measured, three appear to have no significant residual loading. Data was lost on another at a post failure load about 10 tons below the residual loading observed in the two pillar area supports. This suggests that this support probably was not going to have any significant residual loading as well. The lack of residual loading must equate to

dissipation of the roof loading and no residual loading most likely equates to loss of roof control by the support. This may not necessarily imply an immediate roof fall, although that would certainly explain the absence of roof loading. The roof could be breaking up to the point where it is no longer acting as a load bearing member that can transfer load to the roof support.

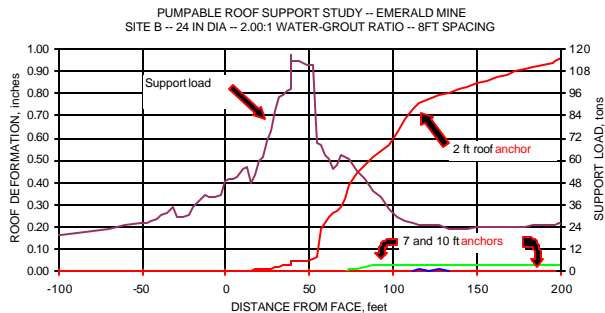
Figure 12. Roof deformation data in conjunction with support loading show that roof deformation did not begin until the peak loading of the support was exceeded.

An examination of the roof deformation data may help to resolve this issue. Figure 12 shows the roof deformation data for the pillar supports in Site B plotted in conjunction with the support loading. It is seen that the roof deformation, which was mostly limited to the lower 2 ft of roof, did not begin to occur until the peak loading of the support was exceeded. The grout in the bag fractures into blocky pieces when the pumpable support reaches its peak load carrying capacity. As the bag tries to confine the grout, the bag bulges and allows the support to compress. This can account for the lowering of the immediate roof. Once the bag develops sufficient confinement and develops some post residual load capacity, the movement of the immediate roof tends to slow down as denoted by the change in slope of the roof deformation curve as the support goes further inby the face. A different behavior was observed for the other supports which exhibited no residual loading. Two things appear to be different: (1) the roof movement occurred prior to the peak loading of the support, indicating it was contributing to the loading of the support, and (2) the separation or movement occurred higher up (to 7 ft) within the roof. Examination of figures 13 and 14 indicate that the immediate roof is delaminating prior to the supports reaching peak loading. This might also suggest that the roof had broken up and essentially lost its capability to transfer load which caused the reduction in support loading rather than the failure of the support grout. However, since there is not sufficient deformation after the support peak loading to validate this claim, and since the peak loading of the supports are similar to the supports in Site B which did exhibit a residual capacity, it is still likely that the supports were indeed failing (loaded beyond their peak capacity).

observed in figure 12 for the pillar area support, where a very small increase in roof movement (0.02 inches) resulted in an immediate and large increase in support loading (22 tons). This most likely accounts for the low support capacity observed in this support, but why it happened in this particular support remains unknown. It may be that the sudden roof movement damaged the support in some way that degraded its capability to develop loading. The roof movement decelerated following this initial large increase, and during this period the support loading accelerated until its peak capacity was reached. Again, this suggests that the support was losing its capability to sustain loading during this period.

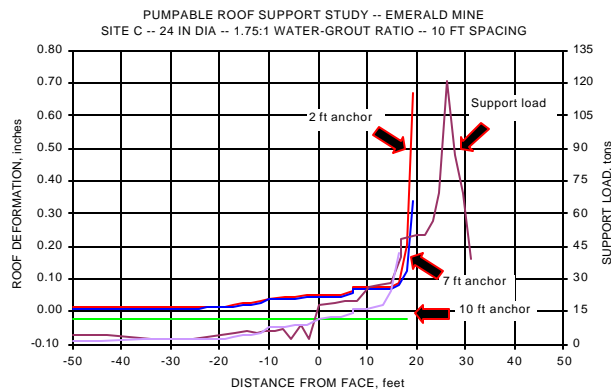
Figure 13. Roof deformation appears to be contributing to the loading of this support.

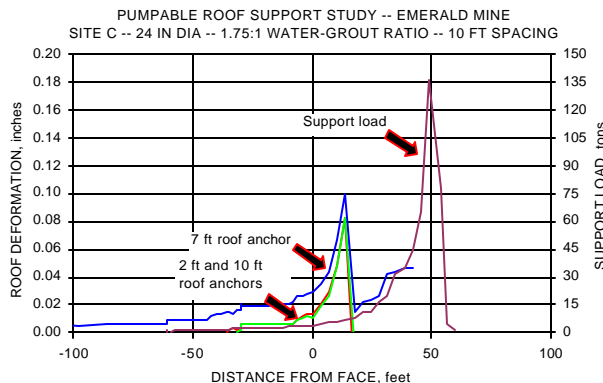
Figure 14. Another example of roof deformation occurring during the support development with no significant post failure load capacity in the pumpable roof support.

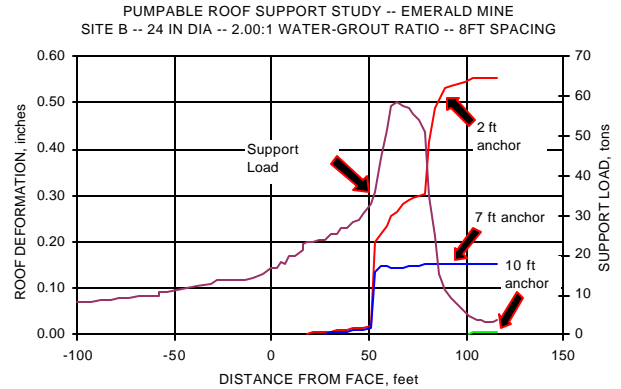
Figure 15. A different loading behavior appears to have taken place in this support which exhibited low peak loading and no significant residual load.

The cross cut support in Site B which exhibited the low peak loading (60 tons compared to 120 tons for the other nearby supports) shows an interesting behavior (figure 15). Here again the roof movements at the 2-ft and 7-ft anchor showed roof movement early in the support loading cycle and this movement caused an increase in the support loading. However, the support increase in support loading was not as dramatic (3 tons increase in support loading for a 0.19 inches or roof movement) as that
